Rowe CBA, CBA-2 UCBA-2
CBA-4 and UCBA-4s

An overview By Bruno D Puglia

March 10, 2005

East Coast Amusements

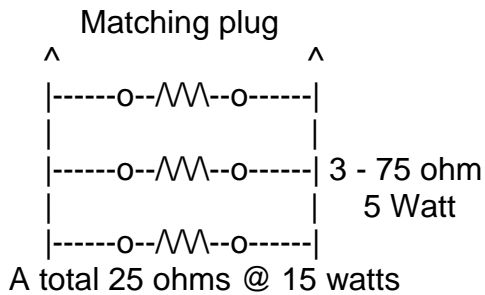
//// Power supply transformer \\\

The power supply may appear to be just a transformer but there is a full wave bridge and a filter cap located with the transformer case. In the case of the COINCO CBA-2 supply there is addition electronics located with the transformer case for interface circuits. If you decide to swap a CBA-2/UCBA transformers, a voltage test should be made first. If the power supply is bad, you might BLOW the second CBA-2 or UBA. Always check the voltage and AC ripple voltage before attaching a power supply transformer to a CBA-2/UCBA-2. To do a stand alone voltage test a resistor load of 25 ohms at 15 watts can be made from three (3) 75 ohm, 5 watt resistors.

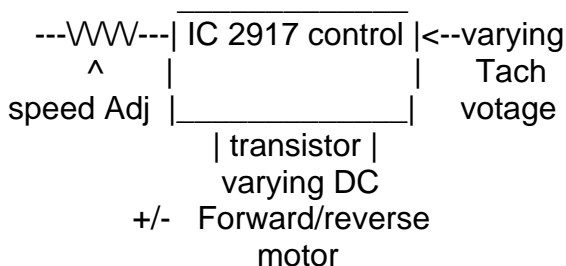
===== CBA Motor Systems =====

The speed adjust resistor sets a reference

that is compared to the Tack signal coming from the motor. Normally if controller does not see the motor's tach signal, the motor will at very high speed. No tach signal could be a bad connection of either one or both of tach wires that bring the signal back to the controller. It could also be a bad tach signal within the motor or a controller with a problem like a shorted motor transistor or bad 2917 IC.

In a case the motor running at hi-speed, the tach wire was open at the cable plugged into the acceptor connector. An ohmmeter test was made but cable was left connected on both ends when the test was made. The broken (open) connection was not found because leaving the cable connectors plugged into the equipment and he used the signal tone and diode position on the meter. This gives misleading test results. It is a false positive. The best way to check a cable is to plug mating connectors into the cables connectors and measure the resistance on the mating connectors.

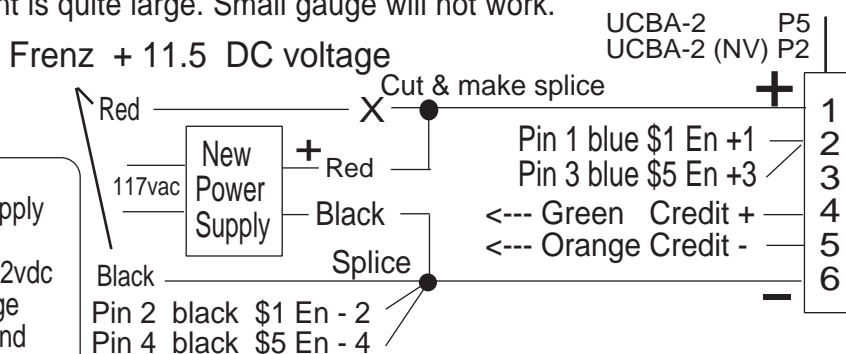
Full Court Frenz II with UCBA-2: Switch settings = 2 6 7 on.

The voltage of 11.5 vdc is too low. Use the Rowe power supply transformer (Part number 4-08231-01) or [other > 12 vdc supply] and put into the system. Pick up the AC after the fuse and switch. At the UCBA-2 DC power plug, cut the Red +11.5 volt wire and tie the new power supply (+) red wire into the UCBA-2. Splice in the (-) side by peeling back some insulation on the black wire near the UCBA-2 and slice the black (-) of the Rowe transformer or power supply to the existing black (-) side of the Frenz II system. Use large gauge wire for power connections to reduce the IR drop in the wire. With motors running the current is quite large. Small gauge will not work.

New power supply:
Rowe CBA power supply
or a small switching
supply with only the 12vdc
is used turn up voltage
adjust to get 13vdc and
use large gauge wires.

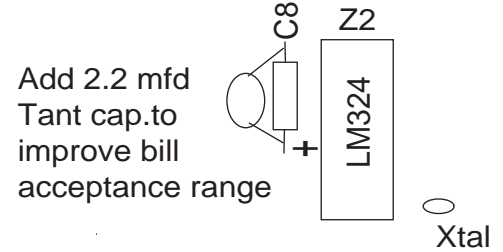
Rowe CBA-1 and 4-50679-0x [05] CCU.
 Vending OEM
 Early Nostalgic
 Juke boxes.
 Bruno Puglia
 East Coast Amusements, Braintree MA

The CBA-1 should be in good shape and lubricated. Since the CBA-1 is similar to the CBA-2 look at the lubrication Bear note for instructions for lubing the CBAs.

You should remove the control unit's cover and check if the improve the bill acceptance range mod has been made. A 2.2 mfd Tantumn cap is added across C8 or the value of C8 is 2.2 mfd. If the 2.2 mfd cap is not there tack a 2.2 mfd cap across C8. Note the + end. If the cap is there, or you installed it, tag the outside so you know the 2.2 update mod has been done.
