Rowe BCxx00 Bill Changers BC100,150,200,1200,1400,2800,3500

An overview by Bruno D Puglia
EAST COAST ADMUSEMENTS
Canton, MA

<http://www.eastcoastamusements.com/>
March 10, 2005

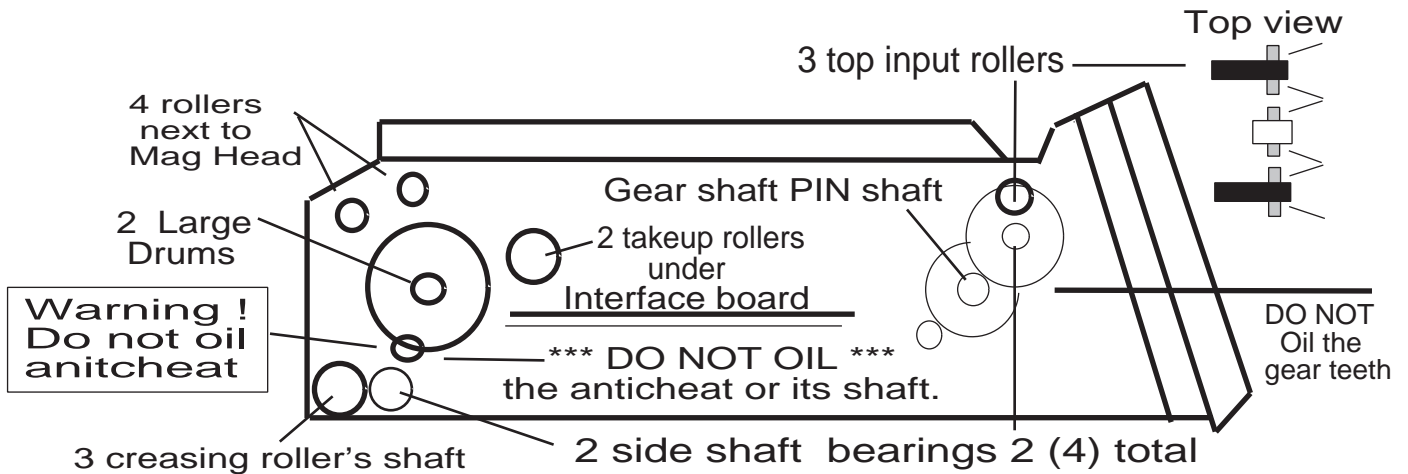
Needle point lubricate every \$30,000 or at least twice a year.

WARNING : DO NOT OVER lubricate or get oil on the belts.

Clean the photo cells and LEDs with Kodax lens cleaner, belts with rubber drive cleaner or denatured alcohol and the mag head pressure rollers with scotch tape or a magnetic pressure roller cleaning card. I have listed the information on Rowe's pressure cleaning card below. Even with normal use the ink from bills will contaminate the two pressure rollers. Keep those two pressure rollers clean.

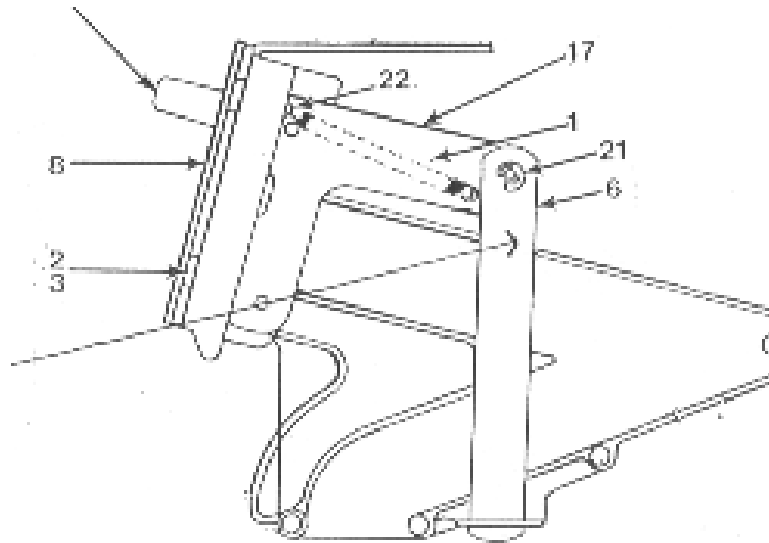
When Rowe started using the Imonex coin mechs in the BC-3500, many coin mechs were damaged. Imonex beefed up the pivot pin but they still broke. I worked out a fix which was to put drill and tap a new screw hole in the bill return scavenge link to limit the downward travel of the link into the coin mech. Rowe later did the same thing. I will attach the BCcoin1 Bear note page to this article to show up how to make the fix in case your BC3500 changer does not have the fix or you put a Imonex coin mech in an older BC3500 or a BC-35 changer. In case you do not use the coin mech I recommend blocking the coin slot with Rowe's Coin Block kit. # 270298-01.

Rowe now installs this screw in BC3500s.

We want to stop the link from going too far down into the coin mech. By adding a screw in the link we can restrict the downward travel into the coin mech. This will prevent damage to the coin mech.

Remove C clip (#21) and the scavenge link (#6). Measure up from the bottom 1 1/4" and this point "S", drill a #29 hole. Tap the hole with 8-32 threads. Place a 1/4" 8-32 screw into the link as shown below. Replace the link and the C clip. Press the Bill Return button and check the coin mech release and also make sure the acceptor motor runs in reverse. If it does not run, re-adjust the return microswitch.

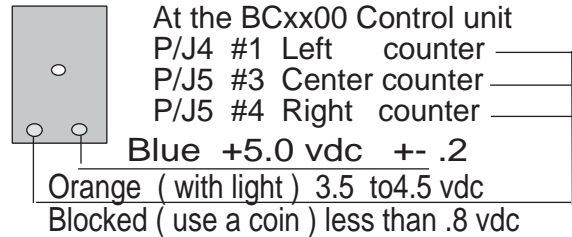
Another part of the coin count system system is the photo cell assembly. Use a meter to check the cell's operation. You need + 5 vdc on the blue wire. You should have => + 3.5 vdc on the orange wire with the LED shining on the cell. When the light is blocked the voltage should below .6 vdc. Refer to the manual for details You may have to push function reset button to clear a coin detector error after doing any testing.

I use the meter on the orange wire to find the peek in voltage has I align the LED assembly. This is better than eye balling the alignment.

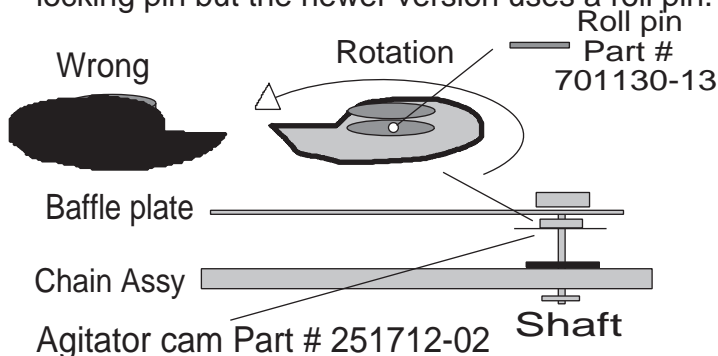
In March 1997 a vendor reported he had gotten upper agitator cams which were defective. The nylon cam was mounted on the metal ring backwards. We found half of the units in our parts box were backwards. We also found two hoppers in our machines with the backwards agitators. We replaced them. The defect may have first shown up in 1996 ! As the cam turns the small edge should start cutting into the coins.

On another note, early versions used an allen locking pin but the newer version uses a roll pin.
