Rowe CBA, CBA-2 UCBA-2
CBA-4 and UCBA-4s

An overview By Bruno D Puglia

March 10, 2005

East Coast Amusements

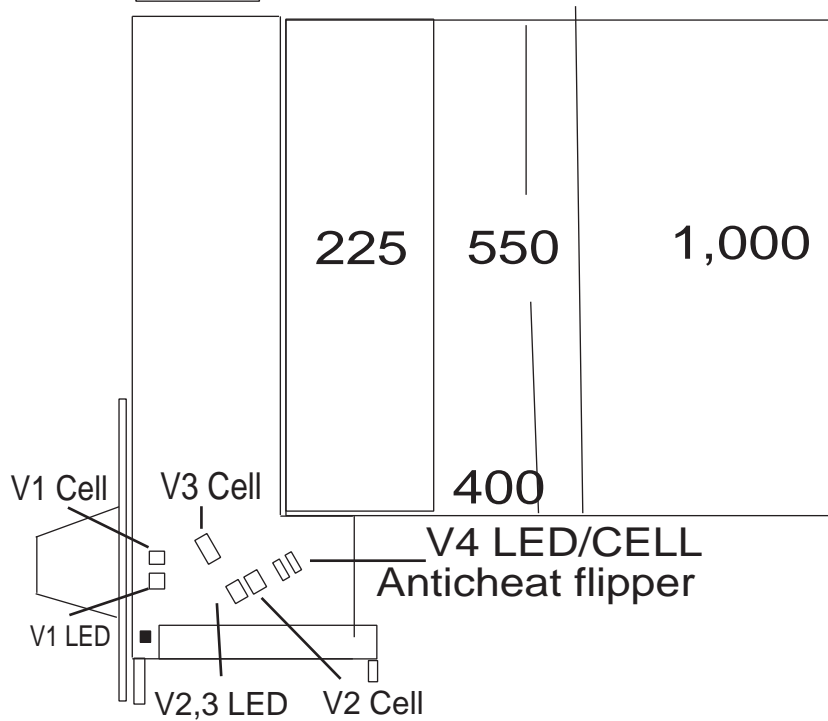
T CBA/UCBA-2

V1 LED is on the bottom and hits V1 cell on the top. The V2,V3 LED is mounted on the lower cell assembly board and supplies light to V3 cell mounting in the Mag head assembly. This same LED supplies the light which is reflected from the back side of the bill to the V2 cell mounted the lower cell assembly board. Errors or problem will be noticed with the number of status blinks
