Rowe BCxx00 Bill Changers BC100,150,200,1200,1400,2800,3500

An overview by Bruno D Puglia
EAST COAST ADMUSEMENTS
Canton, MA

<http://www.eastcoastamusements.com/>
March 10, 2005

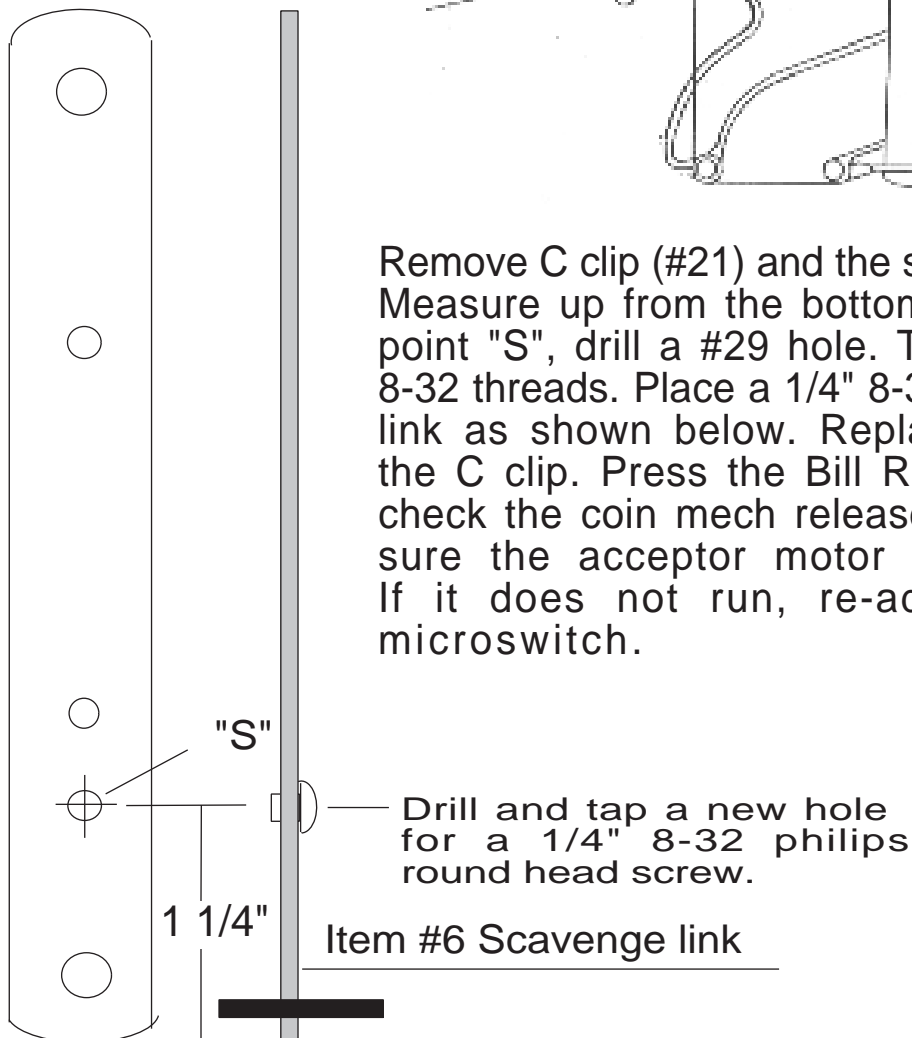
We want to stop the link from going too far down into the coin mech. By adding a screw in the link we can restrict the downward travel into the coin mech. This will prevent damage to the coin mech.

Remove C clip (#21) and the scavenge link (#6). Measure up from the bottom 1 1/4" and this point "S", drill a #29 hole. Tap the hole with 8-32 threads. Place a 1/4" 8-32 screw into the link as shown below. Replace the link and the C clip. Press the Bill Return button and check the coin mech release and also make sure the acceptor motor runs in reverse. If it does not run, re-adjust the return microswitch.

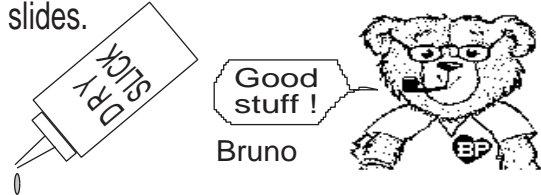
Dry Slick !

What can you use to clean Rowe hoppers and your coin mechs ? A product called Dry Slick is a very good cleaner when wet and when it dries, it leaves slick surface film which does not collect dirt. I do not recommend its use where a build up will cause a serious tightening. (such as tight shaft and nylon bearing). There is no problem when used on a Rowe hopper or on a coin mech area where the coin slides.

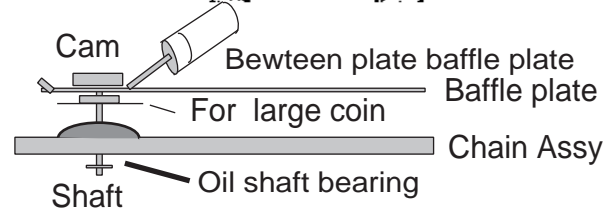
Never use WD-40 on a Rowe machine or acceptor

We have found it pays to oil both nylon bearings used for the hopper shaft. Oiling the area where the cam/s hit the baffle plate with Magic Wand, Radio Shack or 3 in 1 Oil will reduce the amount of friction and make the hopper easier to turn. This will reduce wear and tear on the hopper Motor. Do not use other stuff like WD-40 on the hopper. RAD Dry slick should be used on the chain.
